**Flood Control Project Maintenance
Levee Inspections**

Fall 2013 Levee Maintenance Deficiency Summary Report

Sutter Maintenance Yard Wadsworth Canal

Levee Inspection Report By Mile - Fall 2013

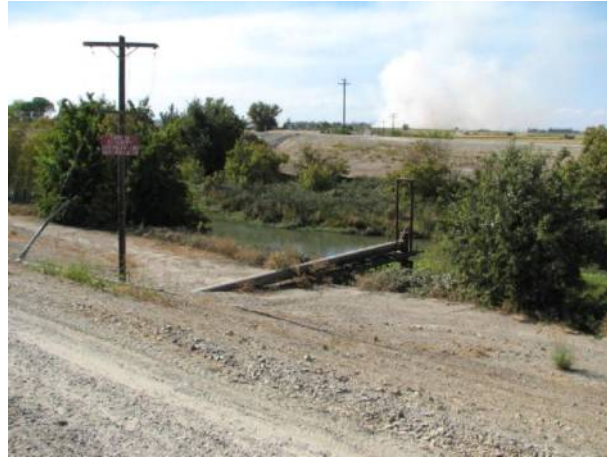
Levee Mile Report Line	7
Start Levee Mile	1.20
End Levee Mile	1.20
Location	Water Side
Category	Supplemental
Item	DWR UCIP Field Study

Power pole with cut powerlines, pump missing from steel pier.

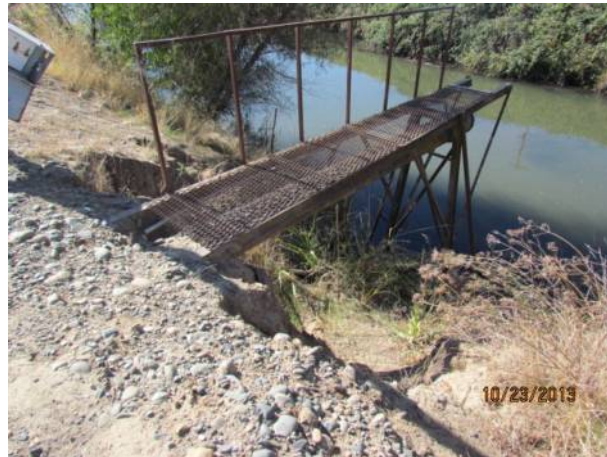
Levee Mile Report Line	11
Start Levee Mile	1.85
End Levee Mile	1.85
Location	Water Side
Category	Earthen Levee
Item	Erosion / Bank Caving

DWR ID:										
11	1.85	1.85	Earthen Levee	Erosion / Bank Caving	WS	M Ma	E1 : Note and monitor erosion site.	39.135110 ° -121.748230 °	39.135110 ° -121.748230 °	107 Y
DWR ID: DWR_ST0010_01_f_2013_107

View of the erosion along both sides of the abandoned pump.

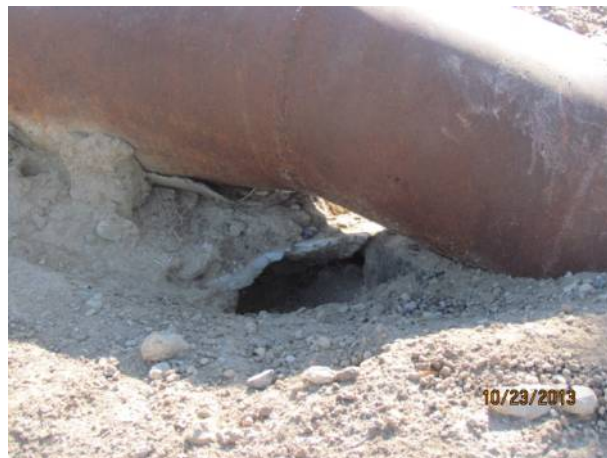
Levee Mile Report Line	12
Start Levee Mile	1.85
End Levee Mile	1.85
Location	Water Side
Category	Earthen Levee
Item	Animal Control

LMR No.	Levee Mile		Category	Item	Location	Rating	Action/Comment	GPS Latitude/Longitude		Issue No.
	Start	End						Start	End	
12	1.85	1.85	Earthen Levee	Animal Control	WS Ma	M	A3 : No rodents visible, but rodent burrows visible; need to backfill and compact or grout burrows.	39.135110 ° -121.748229 °	39.135110 ° -121.748229 °	106 Y
DWR ID: DWR_ST0010_01_f_2013_106										
13	1.85	1.85	Supplemental	DWR UCIP Field Study	WS En	U	Inspector Comments: FS_ID:6747 EP_NO: N/A Repair Type: Urgent Crossing Status: Found UCIP Comments: Pipe abandoned. Pipe open and not plugged. Pipe should be removed or abandoned properly. Extensive animal burrowing occurring along pipe alignment. FIELD_STRUCT_DESC: 14-inch steel irrigation pipe through the levee, 5.7 feet below the crown. Siphon breaker on landward side. Vertical pump on waterward side. Meter pole on berm. Originally in O+M manual, asbuilt available. FS Date: 10/9/2012 11:25:35 AM	39.135091 ° -121.748196 °	39.135091 ° -121.748196 °	103 Y

View of the rodent holes under the irrigation pipe.

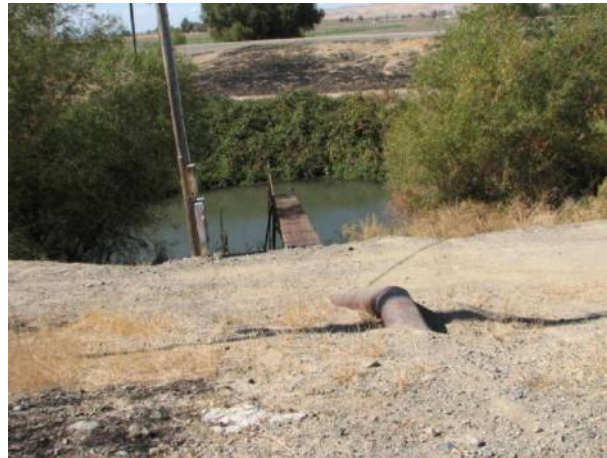
Levee Mile Report Line	13
Start Levee Mile	1.85
End Levee Mile	1.85
Location	Water Side
Category	Supplemental
Item	DWR UCIP Field Study

Pump missing from steel pier on WS toe.

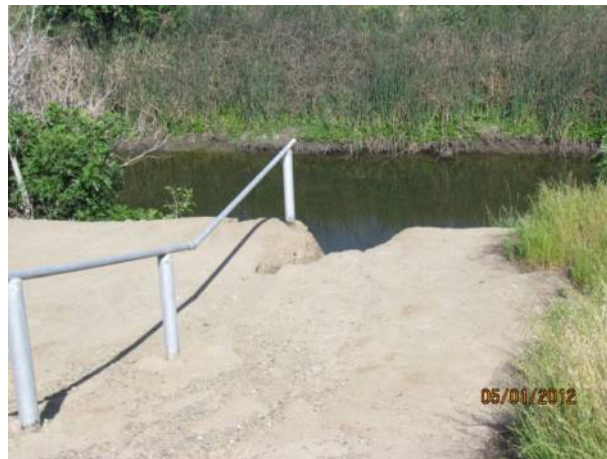
Levee Mile Report Line	15
Start Levee Mile	2.40
End Levee Mile	2.40
Location	Water Side
Category	Earthen Levee
Item	Erosion / Bank Caving

View of the erosion along the fences.

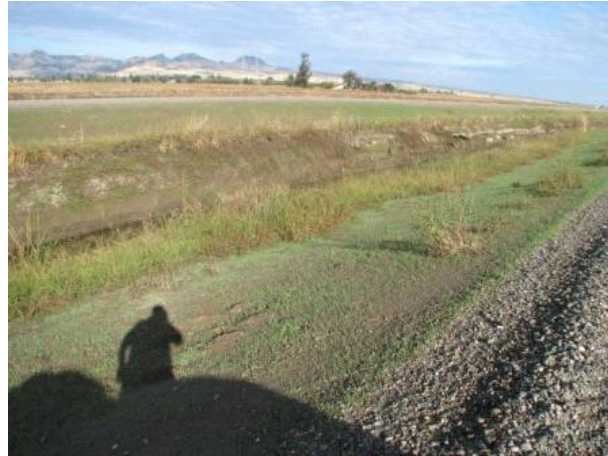
Levee Mile Report Line	20
Start Levee Mile	3.56
End Levee Mile	3.59
Location	Water Side
Category	Earthen Levee
Item	Erosion / Bank Caving

View of the erosion along the waterside toe of the levee.

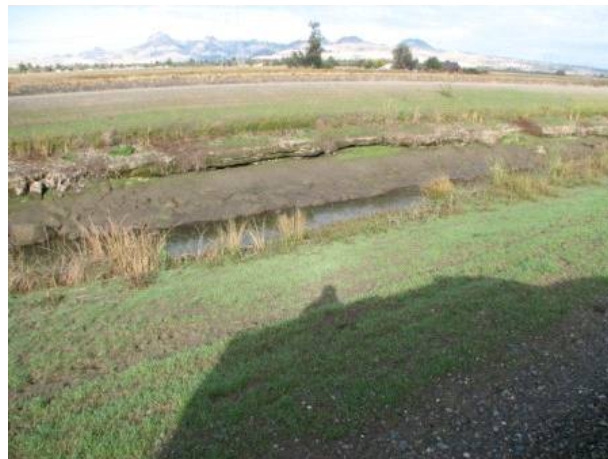
Levee Mile Report Line	21
Start Levee Mile	3.68
End Levee Mile	3.68
Location	Water Side
Category	Earthen Levee
Item	Erosion / Bank Caving

View of the erosion along the waterside toe of the levee.

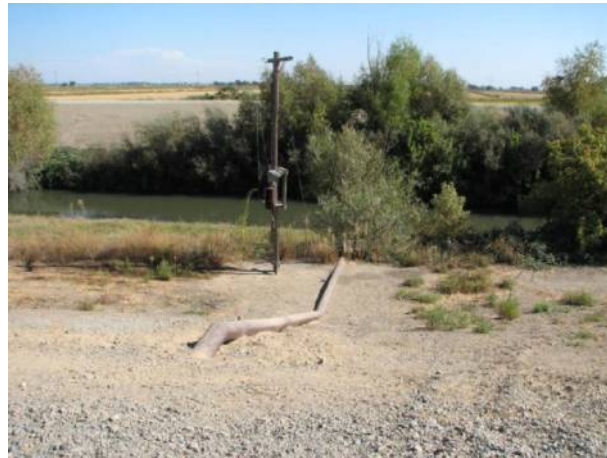
Pipe and pump facilities on WS slope.

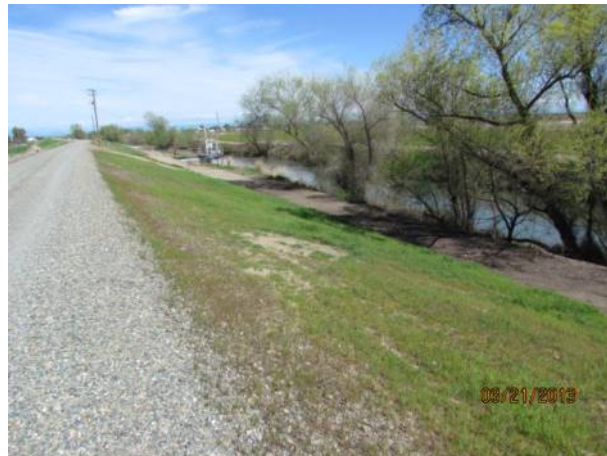
Levee Mile Report Line	7
Start Levee Mile	1.72
End Levee Mile	1.72
Location	Water Side
Category	Earthen Levee
Item	Animal Control

View of the grouted rodent holes.

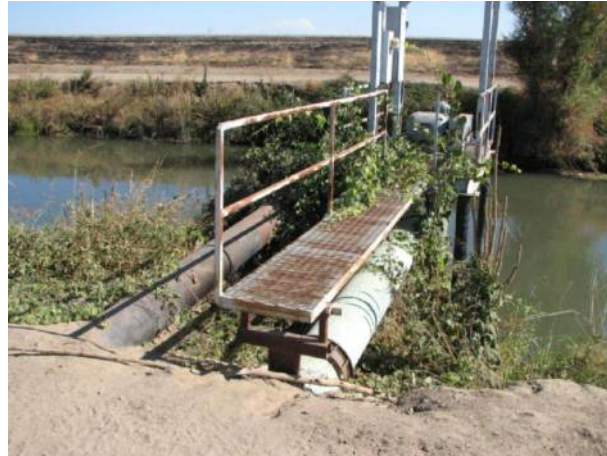
Levee Mile Report Line	10
Start Levee Mile	1.77
End Levee Mile	1.77
Location	Land Side
Category	Supplemental
Item	DWR UCIP Field Study
Pump on steel platform with walkway on WS berm.	
UCIP_7277.jpg

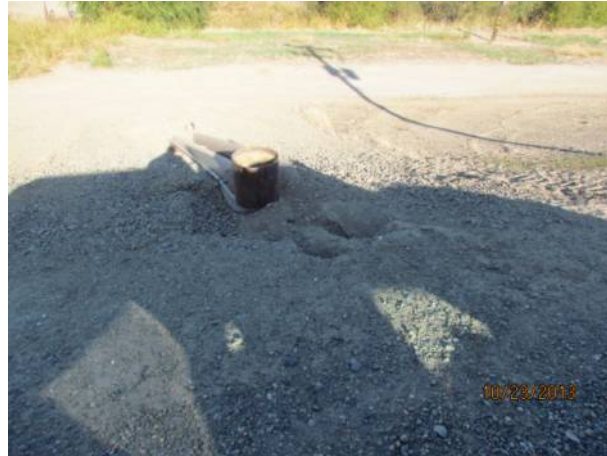
View of the rodent holes above the irrigation pipe.

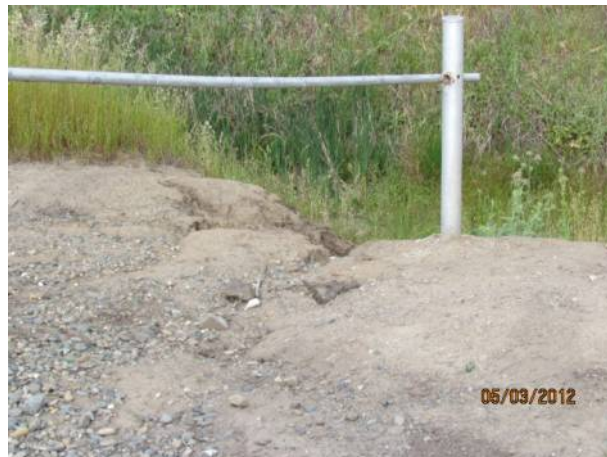
Levee Mile Report Line	16
Start Levee Mile	3.30
End Levee Mile	3.30
Location	Land Side
Category	Earthen Levee
Item	Erosion / Bank Caving

View of the erosion along the W/S toe.

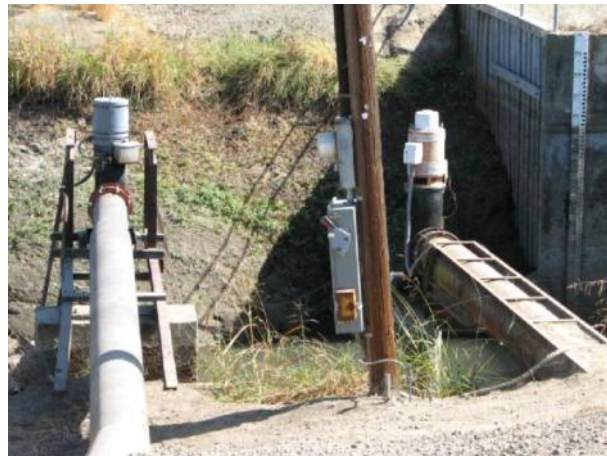
Levee Mile Report Line	19
Start Levee Mile	3.35
End Levee Mile	3.35
Location	Land Side
Category	Supplemental
Item	DWR UCIP Field Study

Pump on steel pier at WS toe.

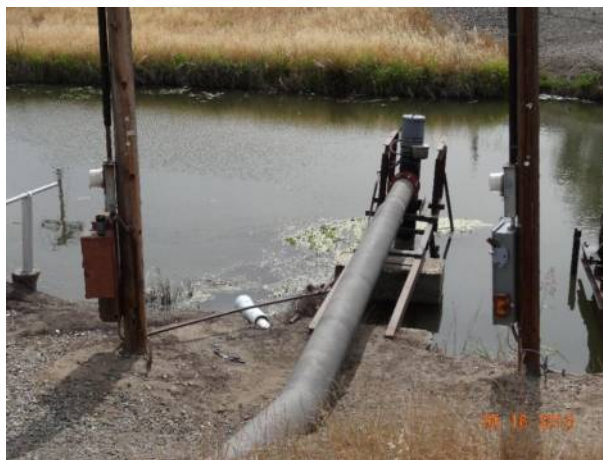
Pump station in channel on WS

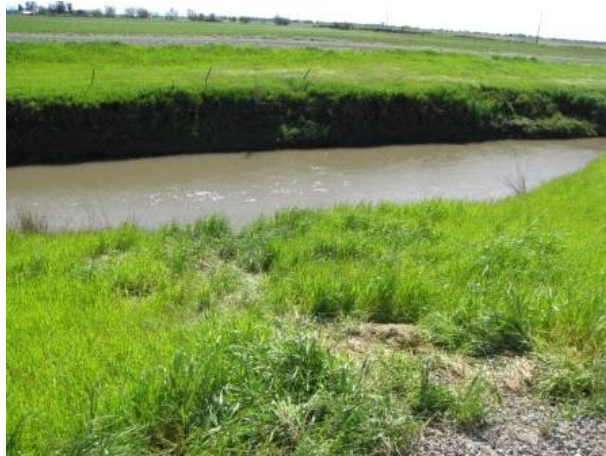
View of erosion along the W/S toe.

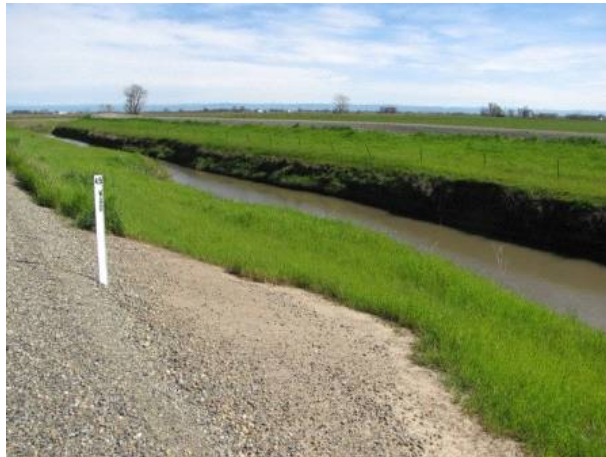
Levee Mile Report Line	26
Start Levee Mile	4.55
End Levee Mile	4.55
Location	Water Side
Category	Earthen Levee
Item	Erosion / Bank Caving

View of the erosion along the W/S toe.
